Escuela Técnico Maya Design + Construction Update

May 10-23, 2010

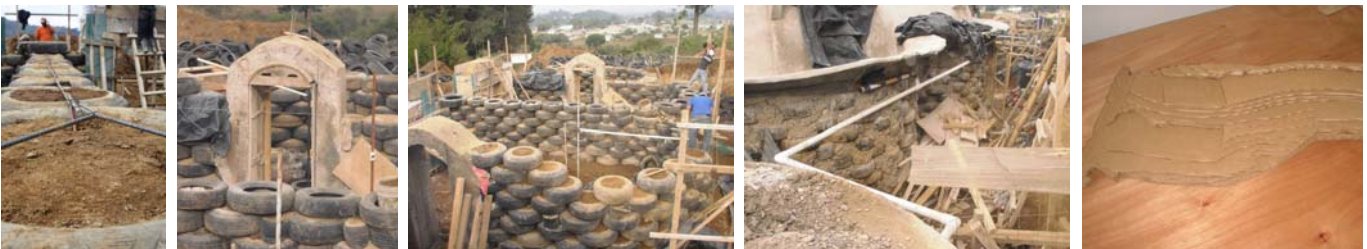
- All four concrete doors have been poured.
- Tire parking continues, 7th course completed, 8th in progress, higher at locations adjacent to doors.
- After the 7th course horizontal rebar (solera) was laid to prevent shear movement between the tires—this is only during construction, the bond beam will protect against shear movement when the walls are complete.

- The roof has been patched with a lime-based sealant to repair in areas where moisture was seeping through.
- The rain water collection system was hooked up and the cistern has begun to fill. With 5 cm of rainfall we have averaged 11 inches of rain in the tank, which is 11 gallons out of the total 4000 the tank will hold. After the tank fills up a little more there will be enough pressure to fill the tubes and have water come out of the taps.

L-R: 1 Rebar on 7th course; 2 Concrete door; 3 Working on 8th course; 4 Pipe bringing rain water from canal to tank; 5 Model base.
